# **ARBORWOOD (BRIDGETOWN PHASE)**

## **LAKE BANK INSPECTION REPORT**

**May 2018**

ARBORWOOD COMMUNITY DEVELOPMENT DISTRICT

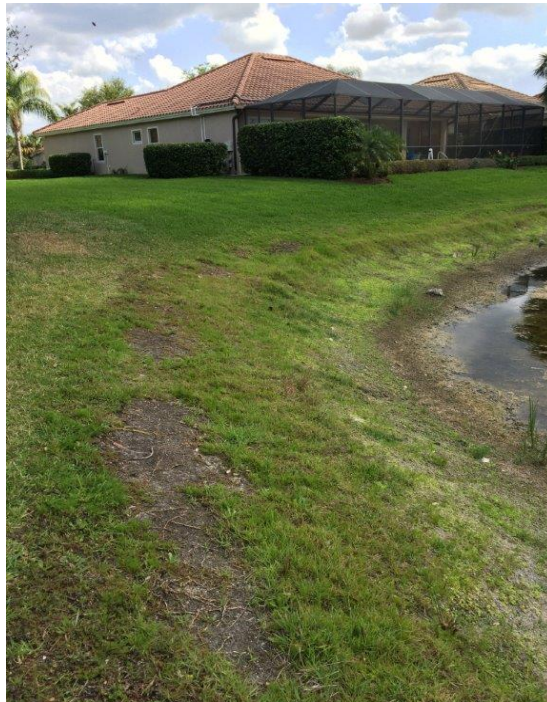
***Photo – #1***

Minor sod loss occurring at the top of the lake slope

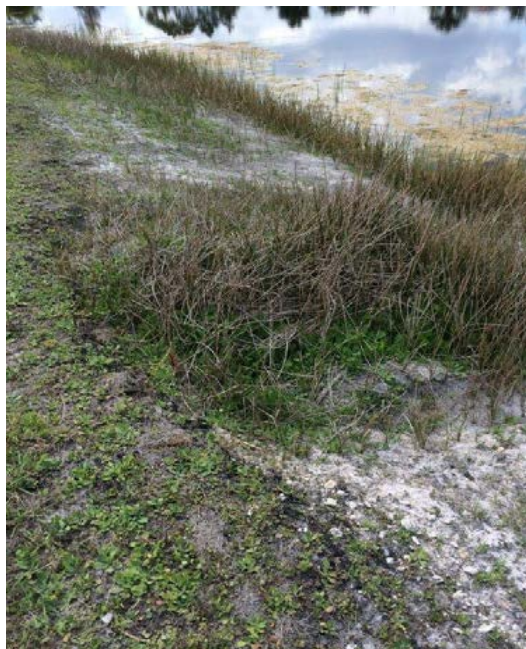
***Photo – #2***

Extensive sod loss leading to erosion on the lake slope

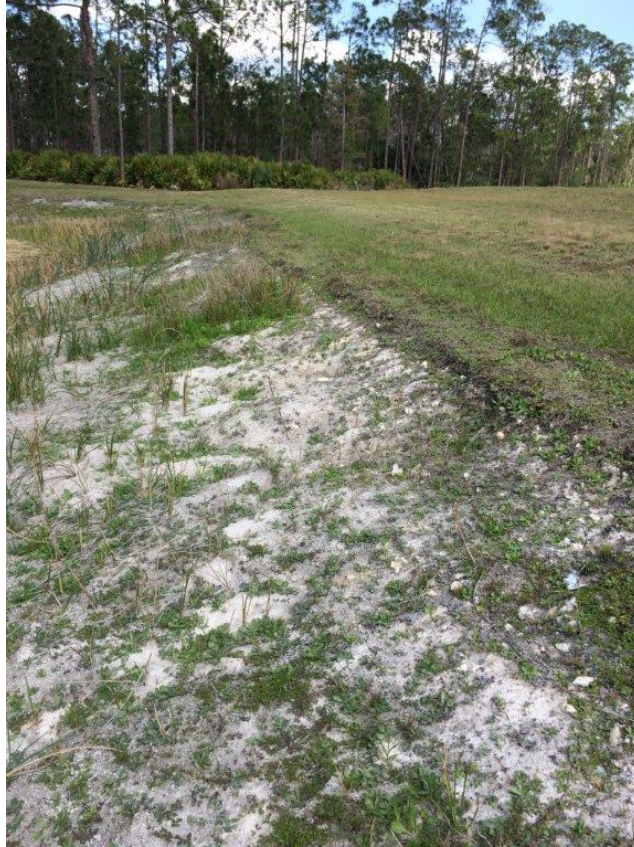
***Photo – #3***

Extensive sod loss has lead to erosion on the lake slope

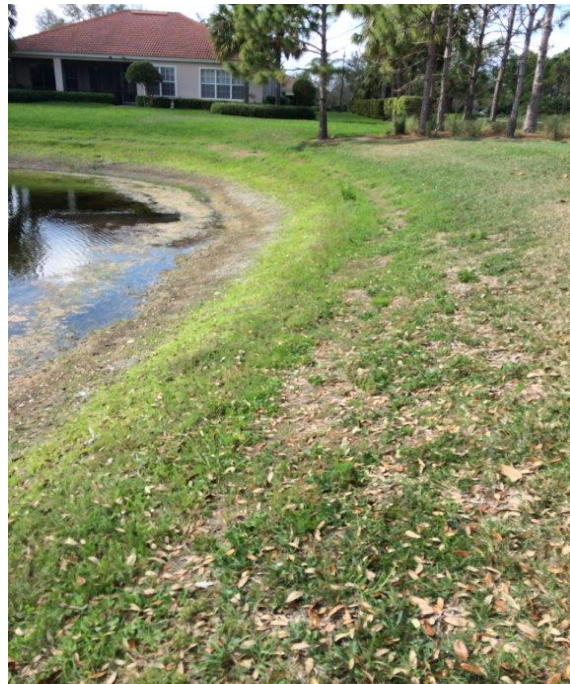
***Photo – #4***

Minor sod loss gradually occurring at the bottom of the lake slope

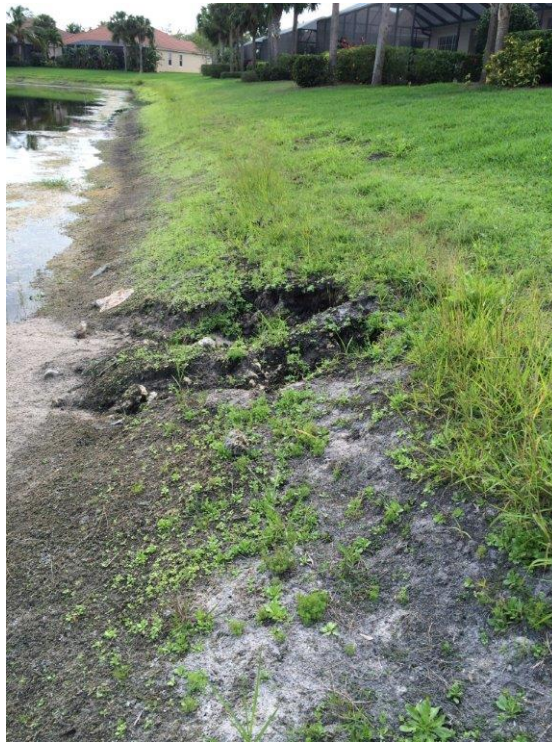
***Photo – #5***

Extensive sod loss has eroded the lake slope and has caused a safety concern for residence

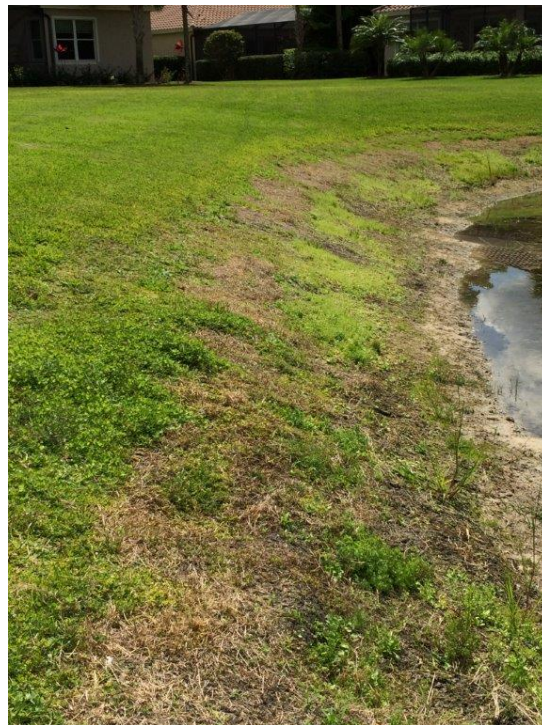
***Photo – #6***

Minor sod loss gradually occurring at the bottom of the lake slope is gradually progressing up to the top of the lake slope

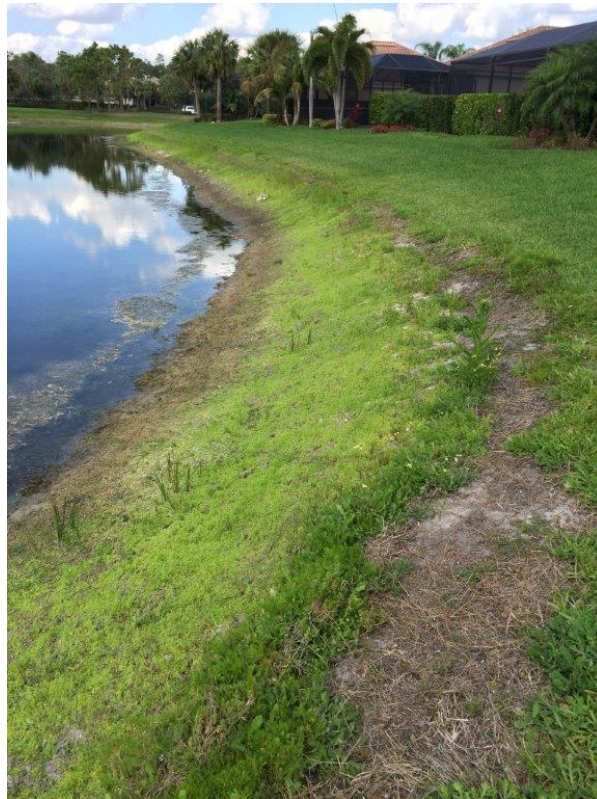
**Photo - #7**

Minor sod loss gradually occurring at the top of the lake slope

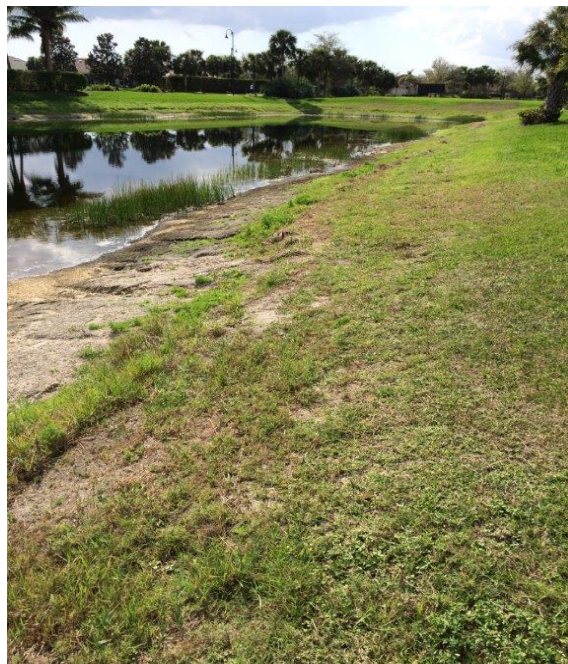
**Photo - #8**

Minor sod loss gradually occurring at the bottom of the lake slope is gradually progressing up to the top of the lake slope

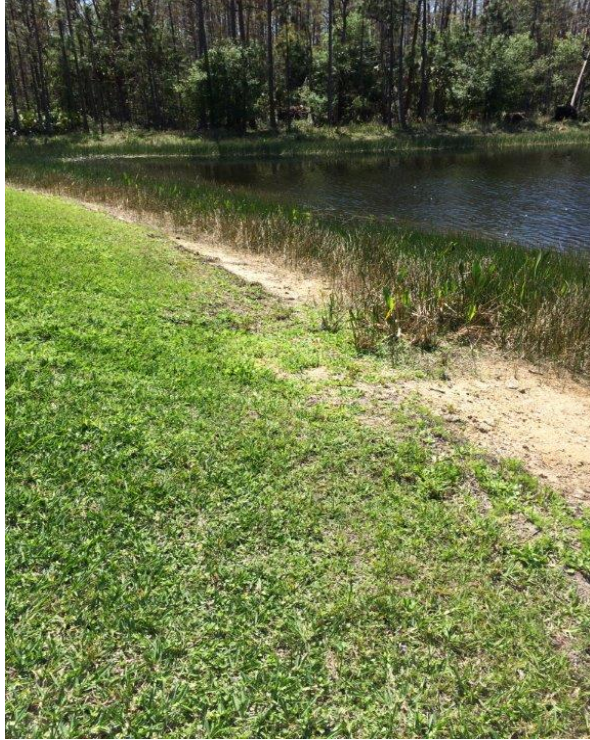
***Photo – #9***

Minor sod loss gradually occurring at the bottom of the lake slope is gradually progressing up to the top of the lake slope

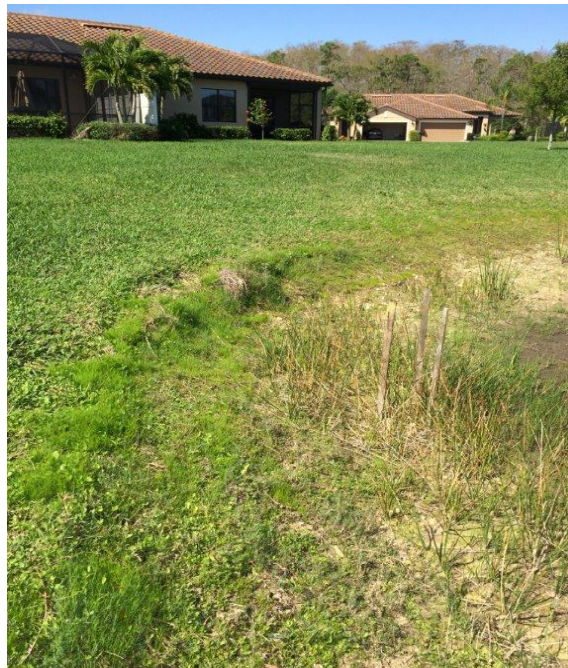
***Photo – #10***

Minor sod loss gradually occurring

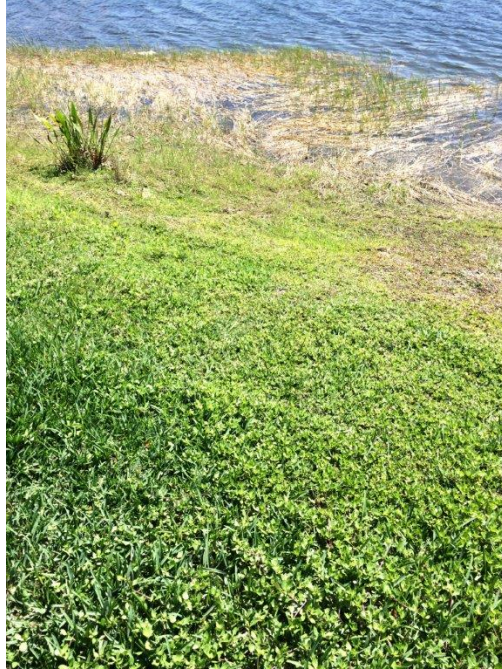
**Photo – #11**

Minor sod loss gradually occurring is causing the soils at the bottom of the lake slope to erode into the lake

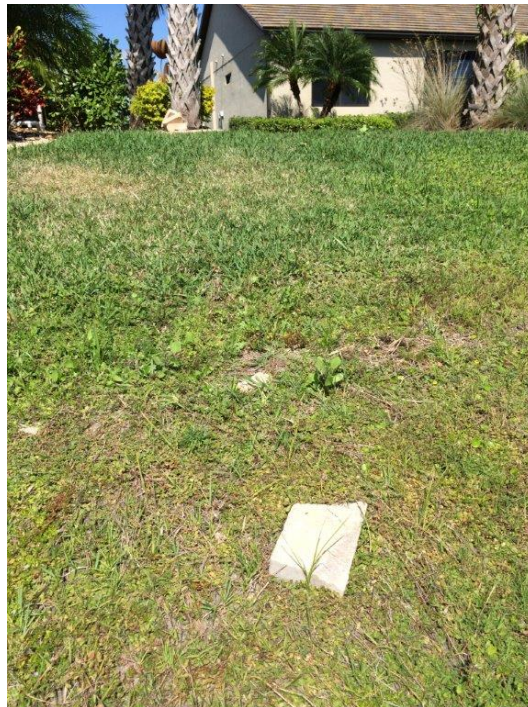
**Photo – #12**

Minor sod loss gradually occurring

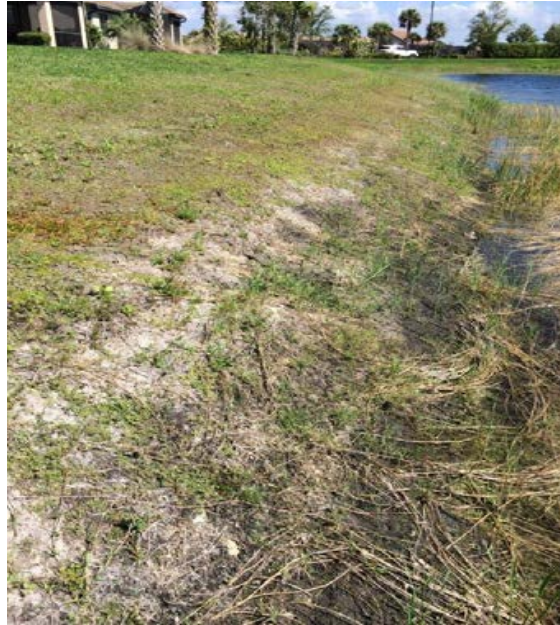
***Photo - #13***

Extensive erosion has occurred near the bottom of the lake slope and is gradually progressing up to the top of the lake slope

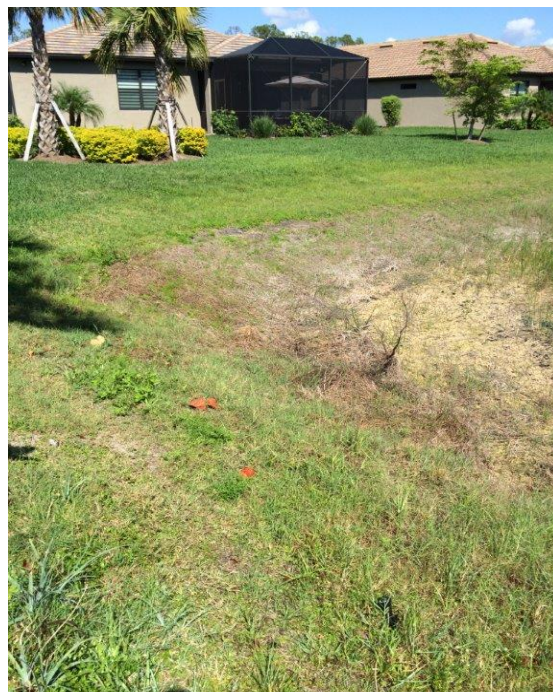
***Photo – #14***

Extensive erosion has occurred near the bottom of the lake slope and is gradually progressing up to the top of the lake slope

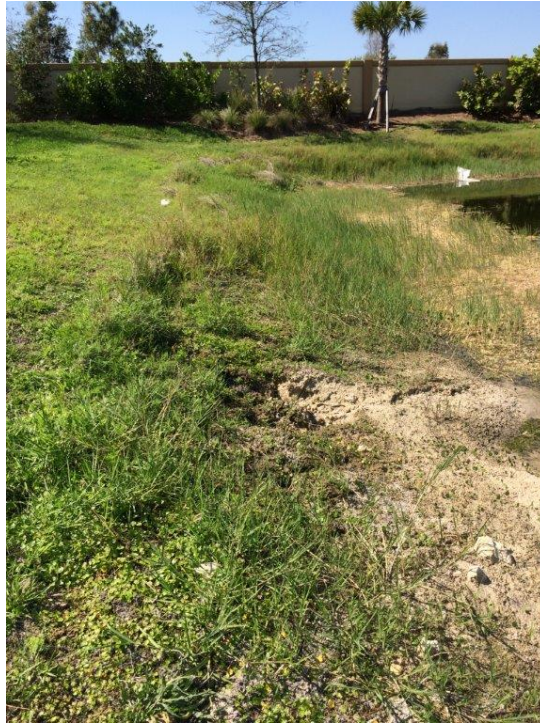
***Photo – #15***

Extensive erosion has occurred near the bottom of the lake slope and is gradually progressing up to the top of the lake slope

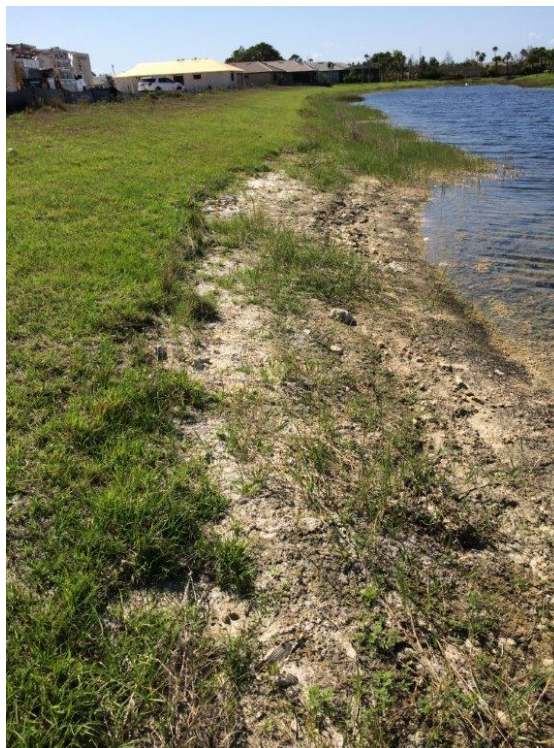
***Photo - #16***

Extensive erosion has occurred near the bottom of the lake slope and has progressed up to the top of the lake slope

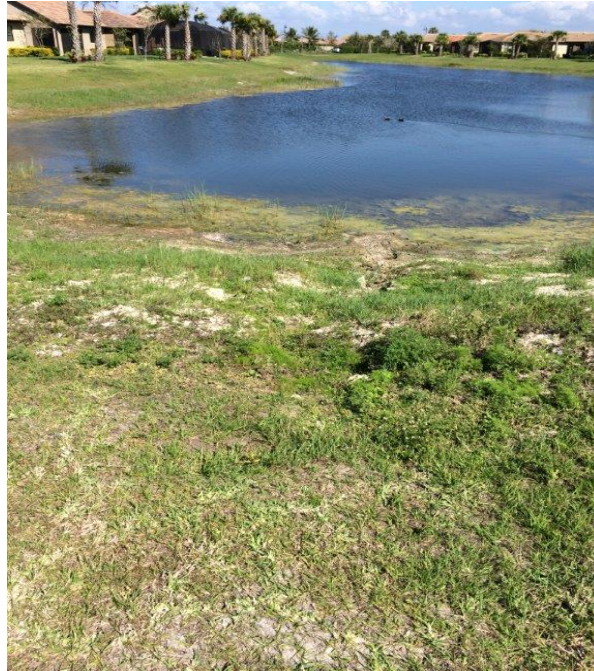
***Photo – #17***

Sod loss has occurred near the bottom of the lake slope and is progressing up to the top of the lake slope

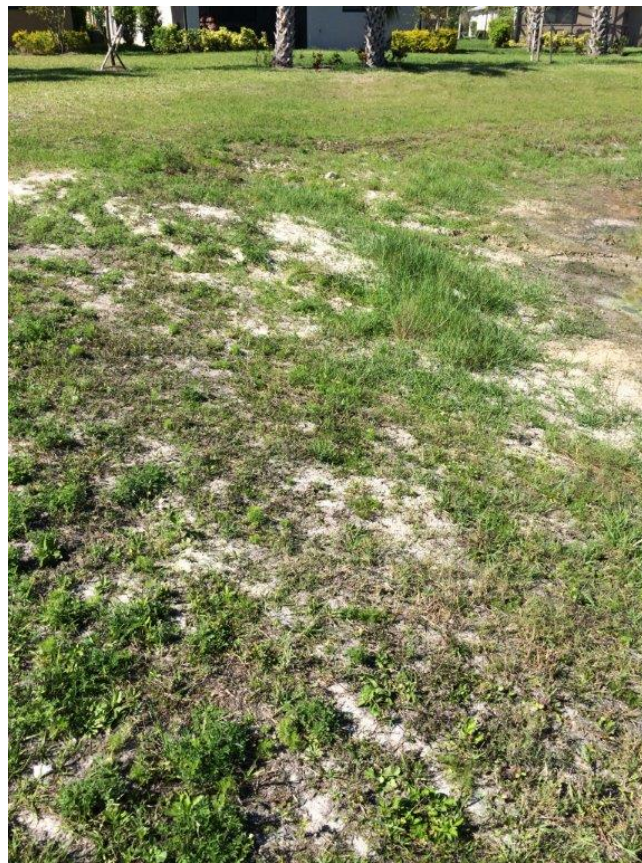
***Photo – #18***

Extensive sod loss has occurred near the bottom of the lake slope and is gradually progressing up to the top of the lake slope

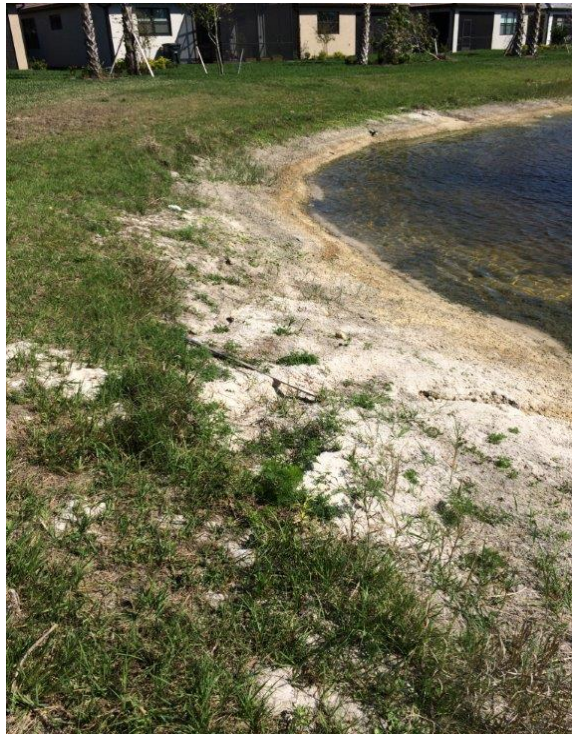
***Photo – #19***

Extensive sod loss has occurred near the bottom of the lake slope and has progressed up to the top of the lake slope

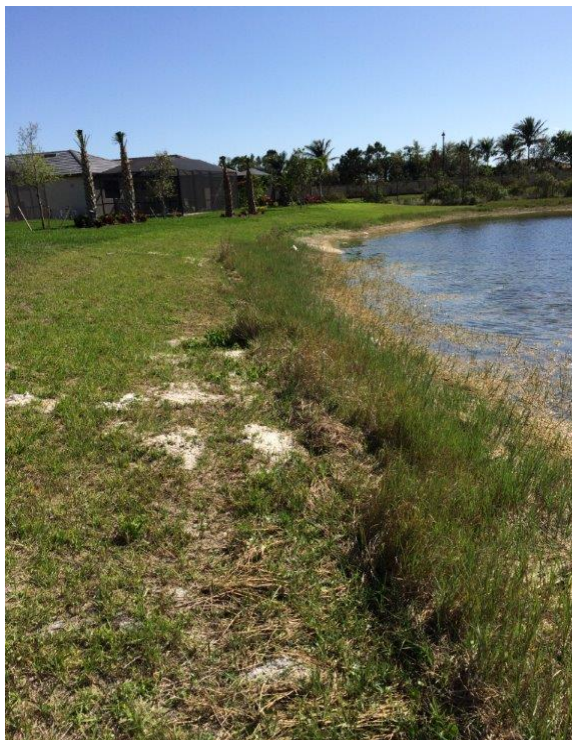
***Photo – #20***

Extensive erosion has occurred near the top of the lake slope

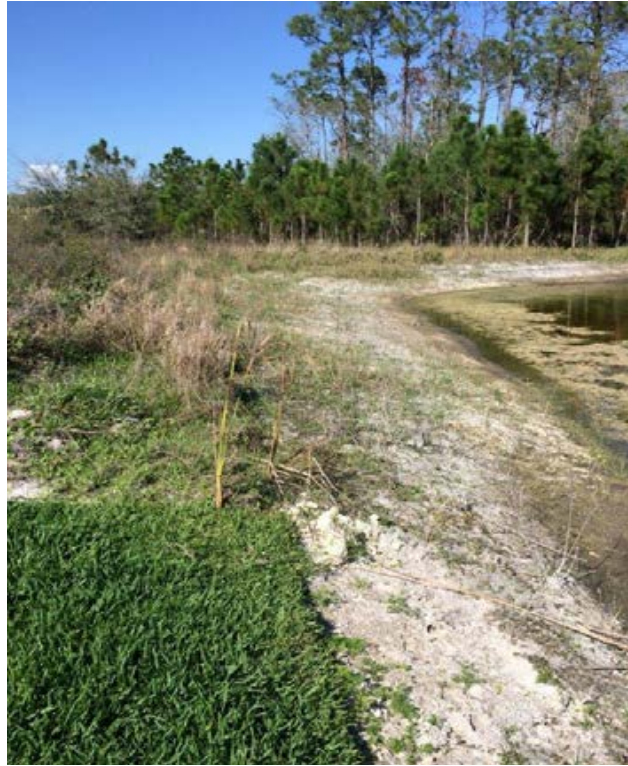
***Photo - #21***

Extensive erosion has occurred near the bottom of the lake slope and has progressed up to the top of the lake slope

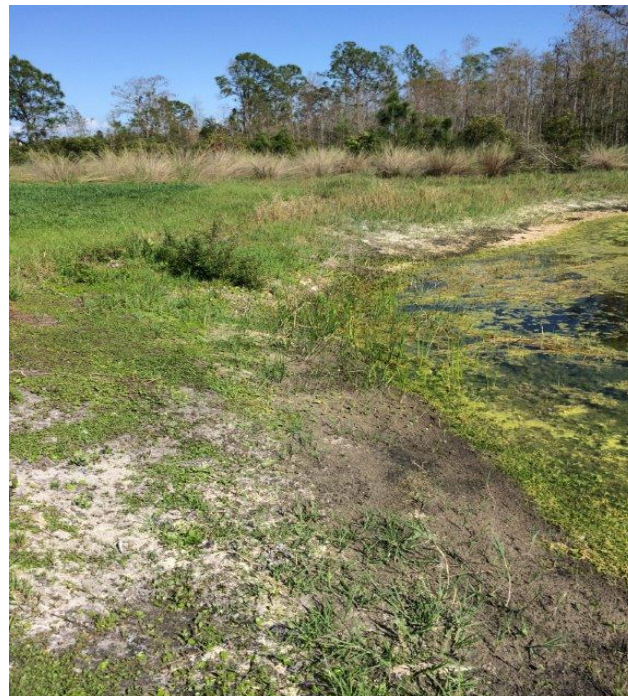
***Photo - #22***

Extensive erosion has occurred near the bottom of the lake slope and is progressing up to the top of the lake slope

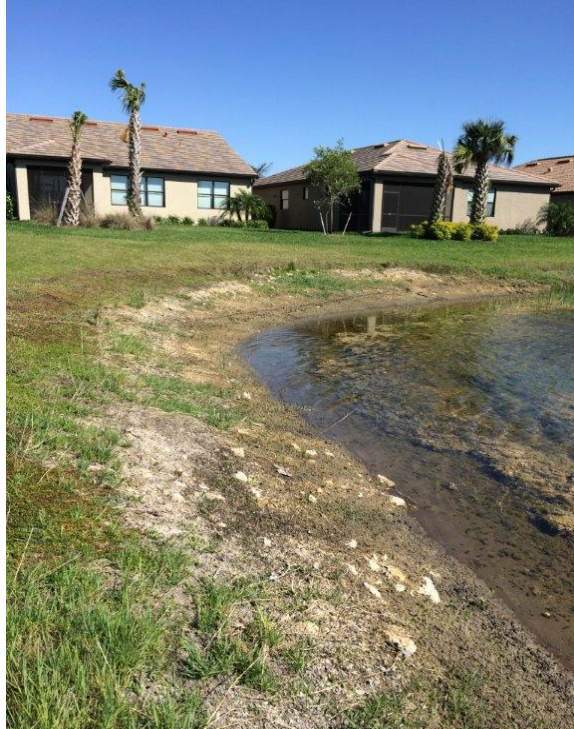
***Photo – #23***

Extensive sod loss has occurred near the bottom of the lake slope and has progressed up to the top of the lake slope

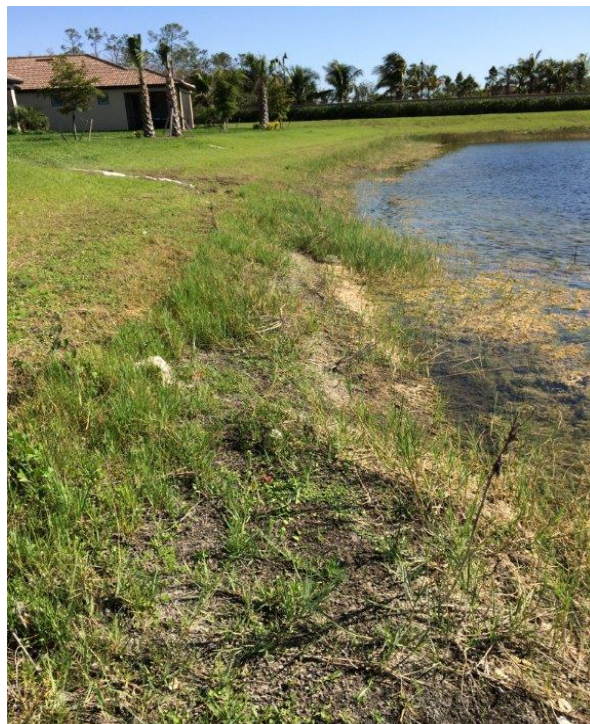
***Photo- #24***

Extensive sod loss and erosion has occurred near the bottom of the lake slope and is progressing to the top of the lake slope

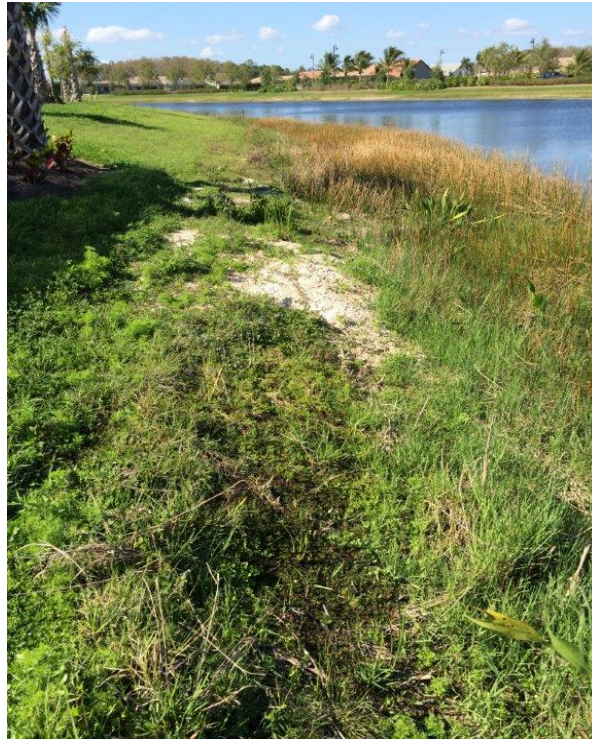
***Photo- #25***

Extensive erosion has created an uneven slope on the top of the lake slope

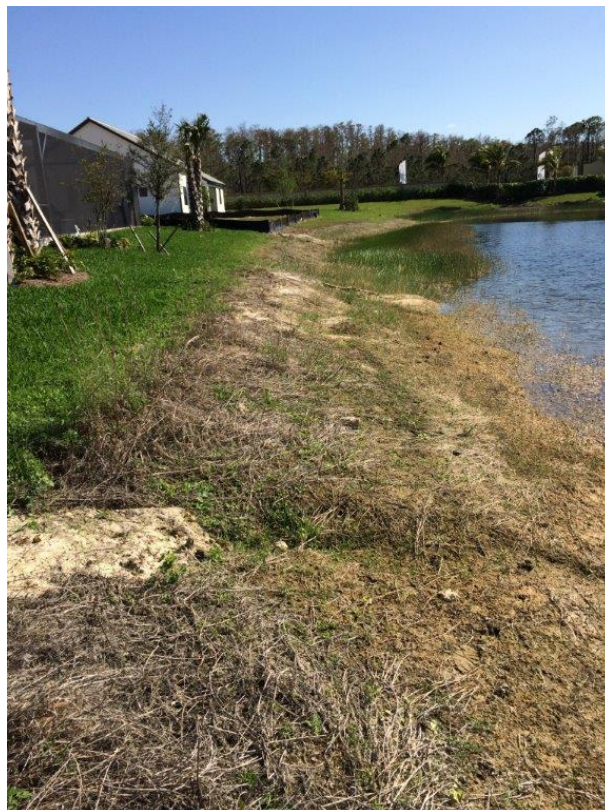
***Photo- #26***

Extensive sod loss and erosion has occurred near the bottom of the lake slope and has progressed to the top of the lake slope
