ARBORWOOD (SOMERSET PHASE)

LAKE BANK INSPECTION REPORT

MAY 2018

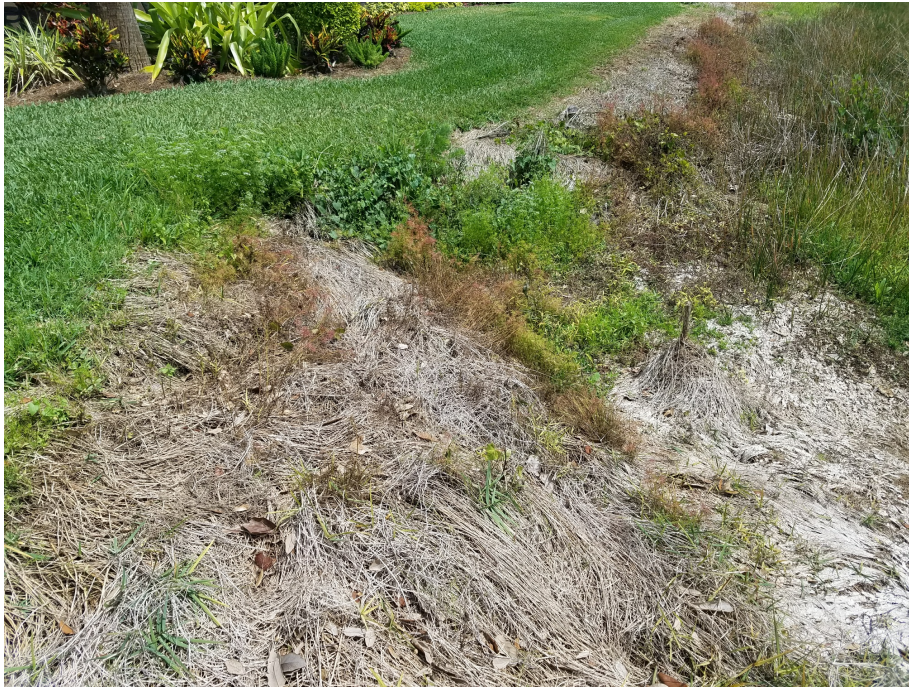
Photo – #1

Major sod loss and erosion occurring at the top of the lake slope and is gradually progressing up to the bottom of the lake slope

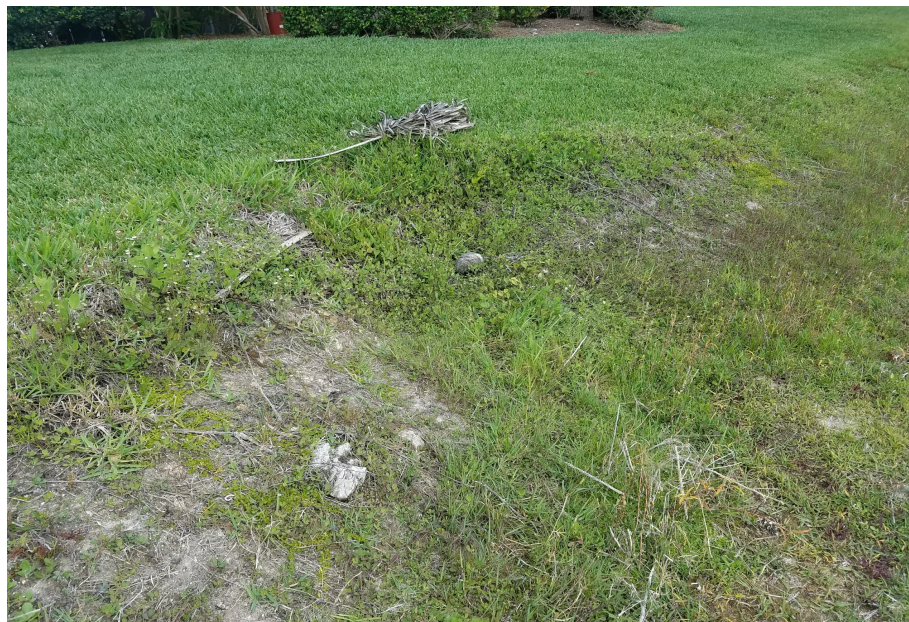
Photo – #2

Sod loss occurring at the top of the lake slope has affected the lake slope

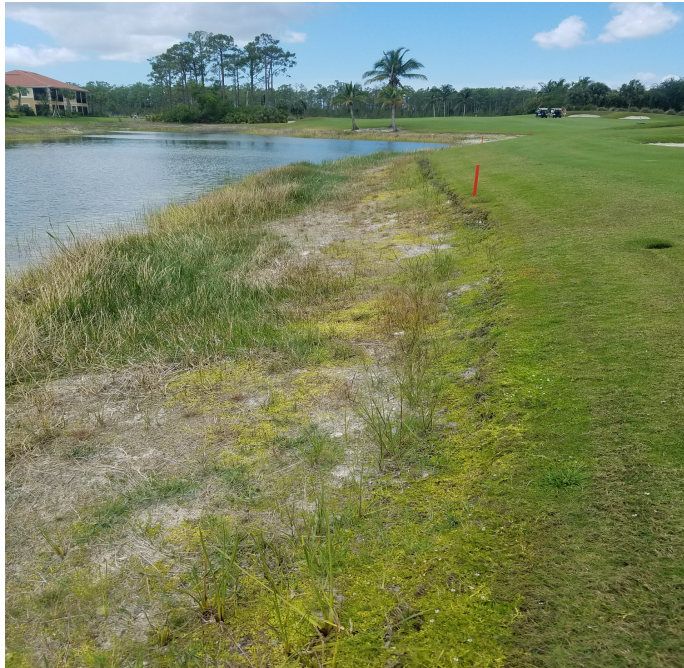
Photo – #3

Minor sod loss gradually occurring at the bottom of the lake slope and is gradually progressing up to the top of the lake slope

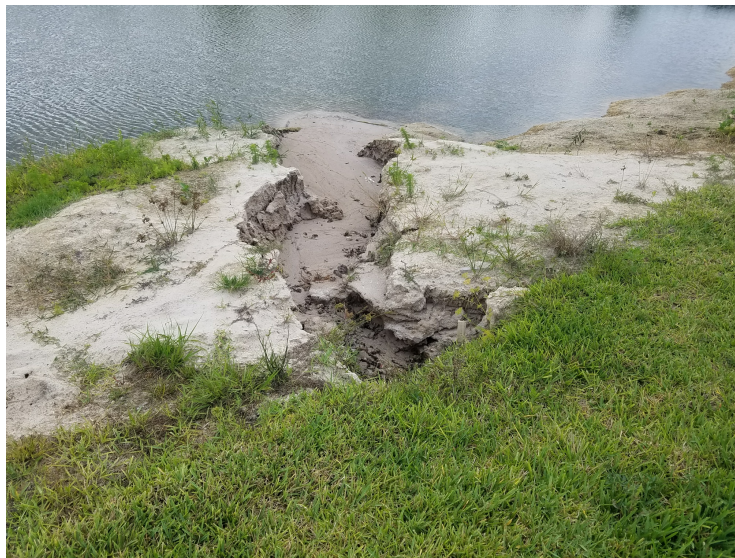
Photo – #4

Major erosion has occurred in the extension of the side yards of adjacent homes where the flow from rear downspouts is concentrated and conducted downslope to the lake

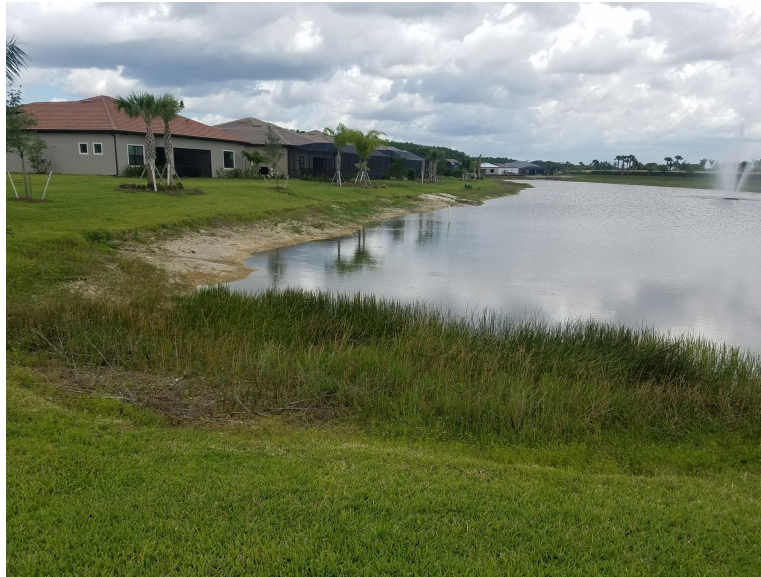
Photo – #5

Major sod loss gradually occurring at the bottom of the lake slope is gradually progressing up to the top of the lake slope

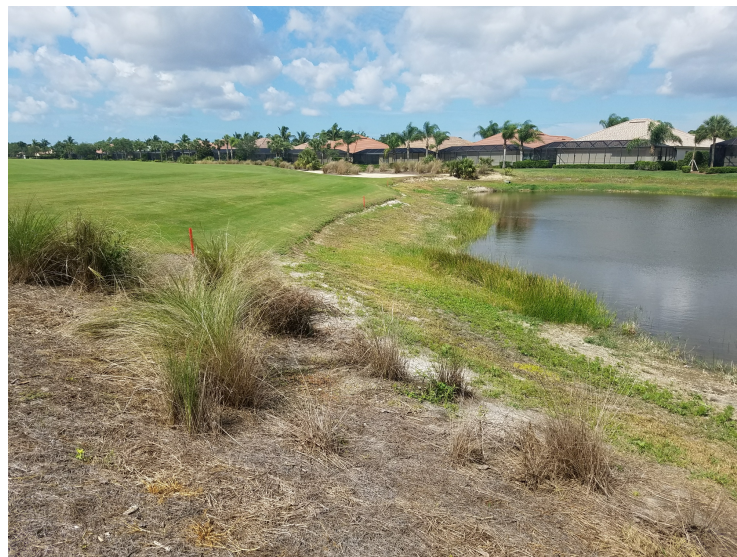
Photo – #6

Major sod loss gradually occurring at the bottom of the lake slope is gradually progressing up to the top of the lake slope

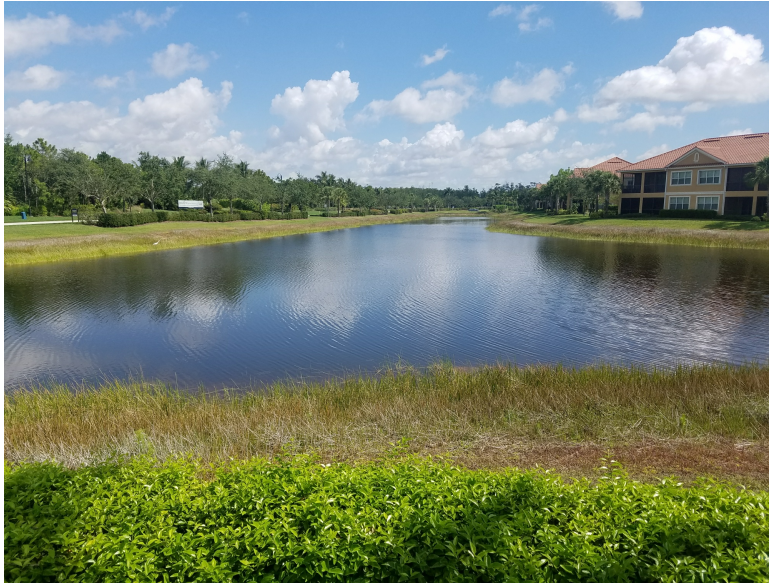
Photo – #7

Minor sod loss gradually occurring at the top of the lake slope

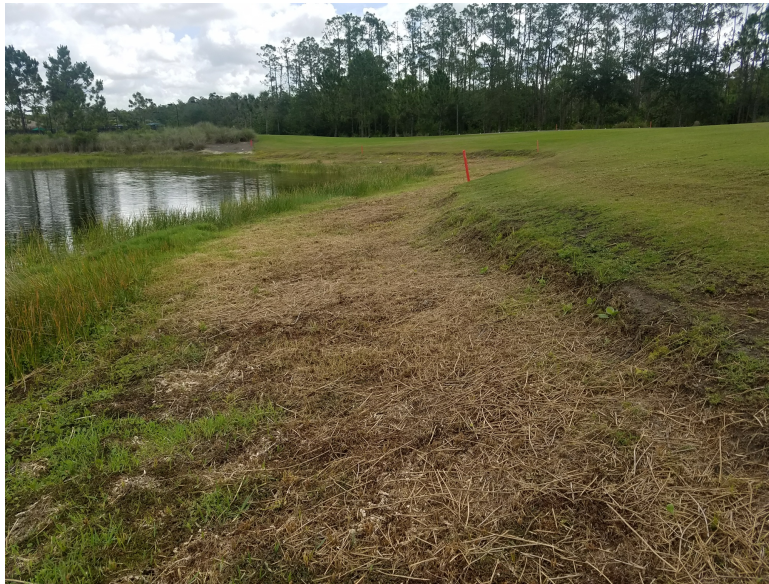
Photo – #8

Minor sod loss gradually occurring at the top of the lake slope has started to erode the slope of the lake

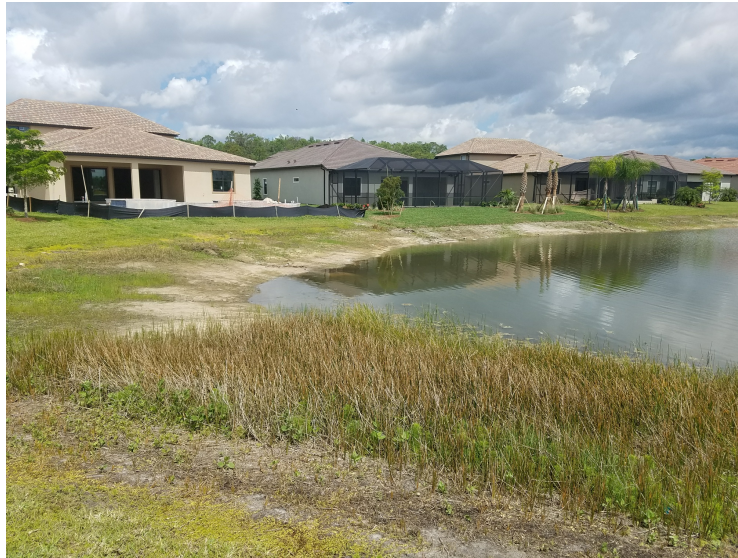
Photo – #9

Major sod loss is gradually occurring at the bottom of the lake slope is gradually progressing up to the top of the lake slope

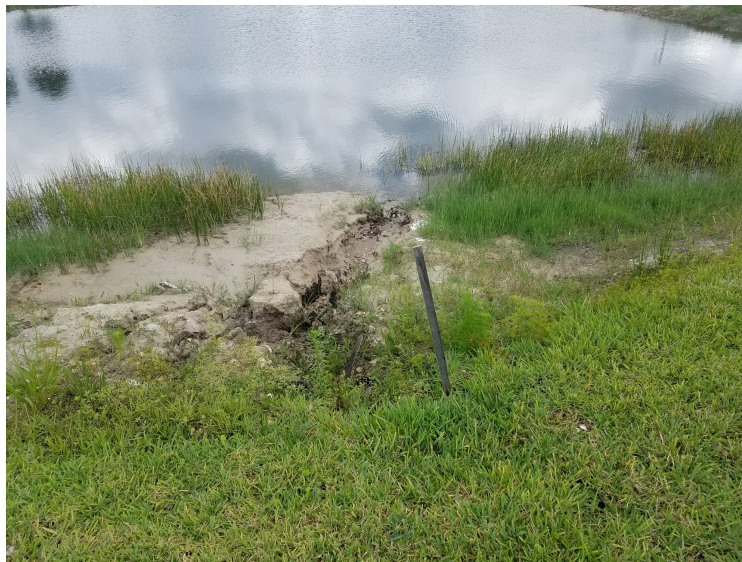
Photo – #10

Major erosion has occurred in the extension of the side yards of adjacent homes where the flow from rear downspouts is concentrated and conducted downslope to the lake

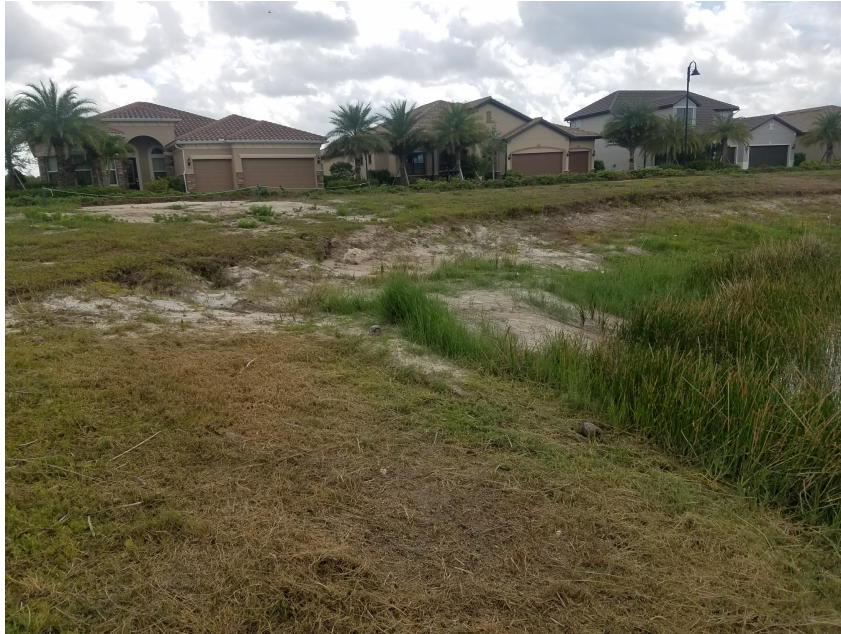
Photo – #11

Major sod loss and erosion is occurring at the top of the lake slope and is gradually progressing to the bottom of the lake slope

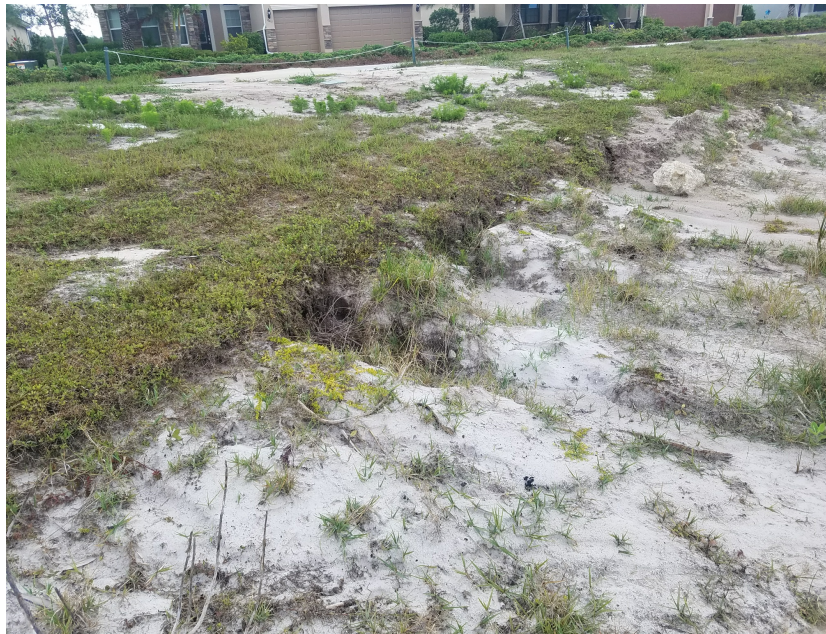
Photo – #12

Major sod loss and erosion is occurring at the top of the lake slope and is gradually progressing to the bottom of the lake slope

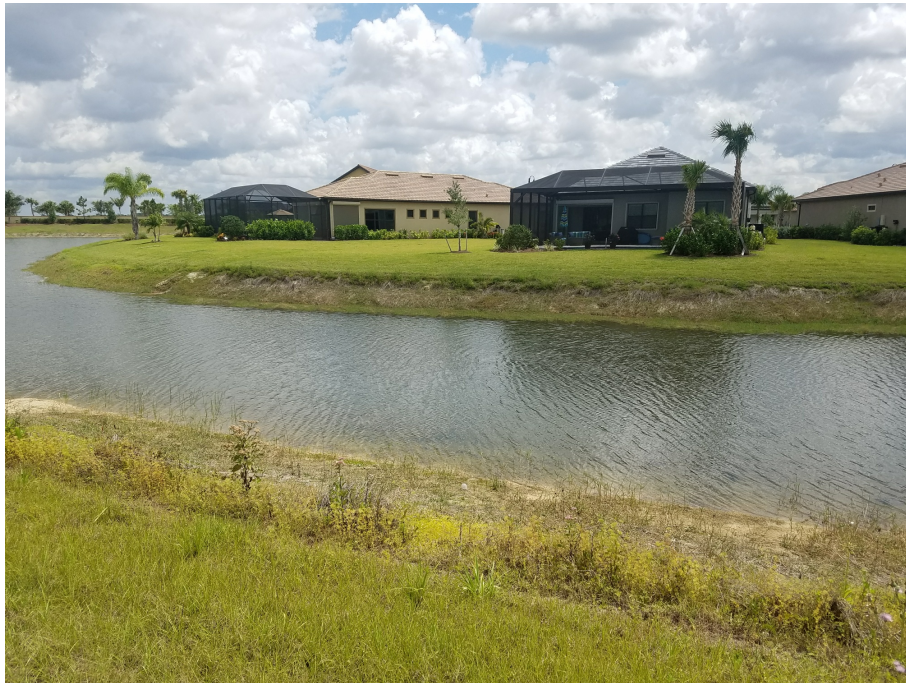
Photo – #13

Major sod loss and erosion is occurring at the top of the lake slope and has caused a drastic change in the lakes designed slope

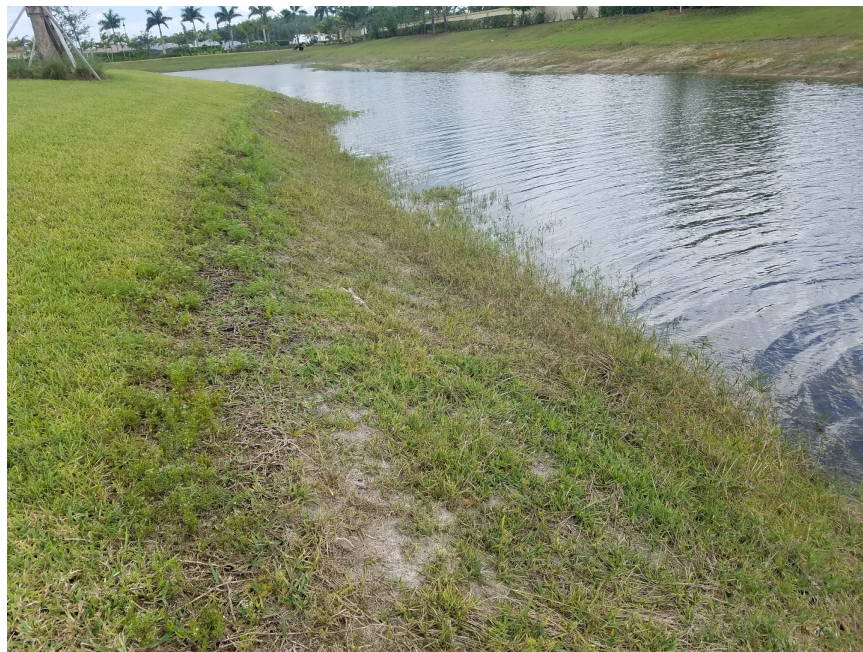
Photo – #14

Sod loss and erosion is occurring at the top of the lake slope and is gradually progressing to the bottom of the lake slope

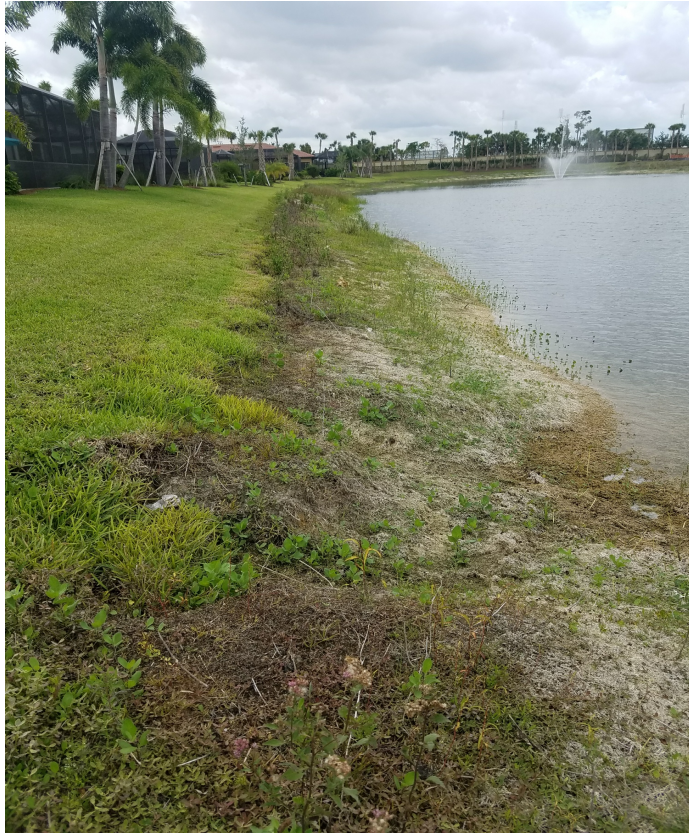
Photo – #15

Major sod loss gradually occurring at the bottom of the lake slope
is gradually progressing up to the top of the lake slope

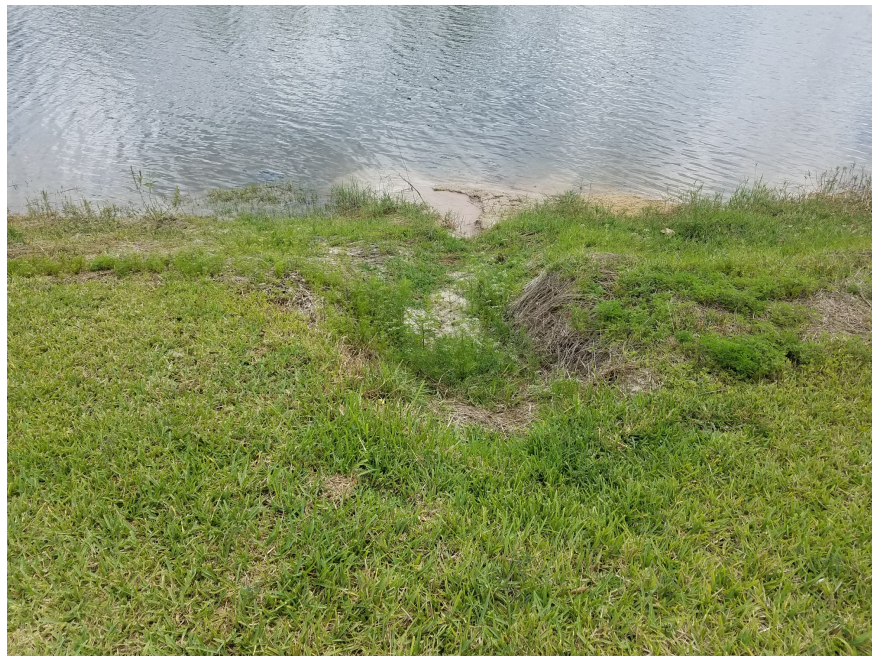
Photo – #16

Major erosion has occurred in the extension of the side yards of adjacent homes
where the flow from rear downspouts is concentrated and conducted
downslope to the lake

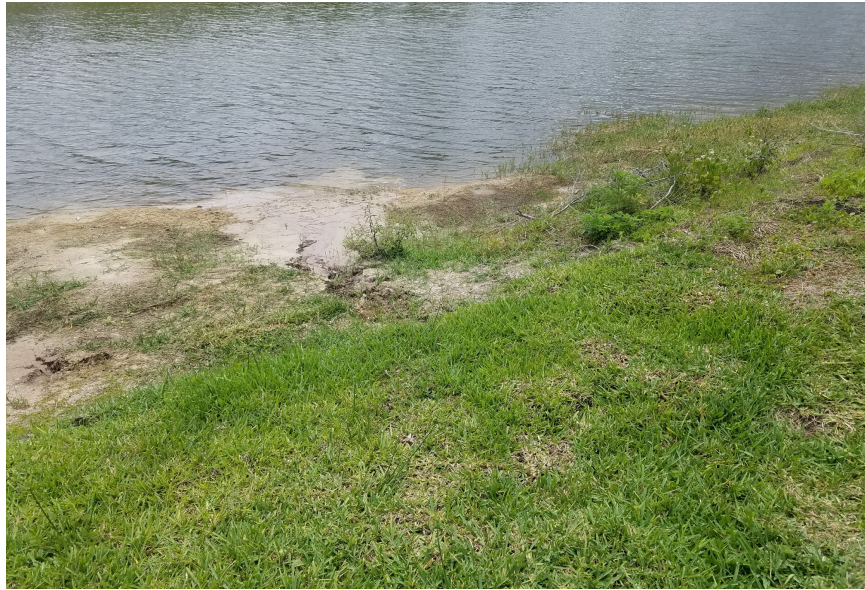
Photo – #17

Major sod loss gradually occurring at the bottom of the lake slope is gradually progressing up to the top of the lake slope

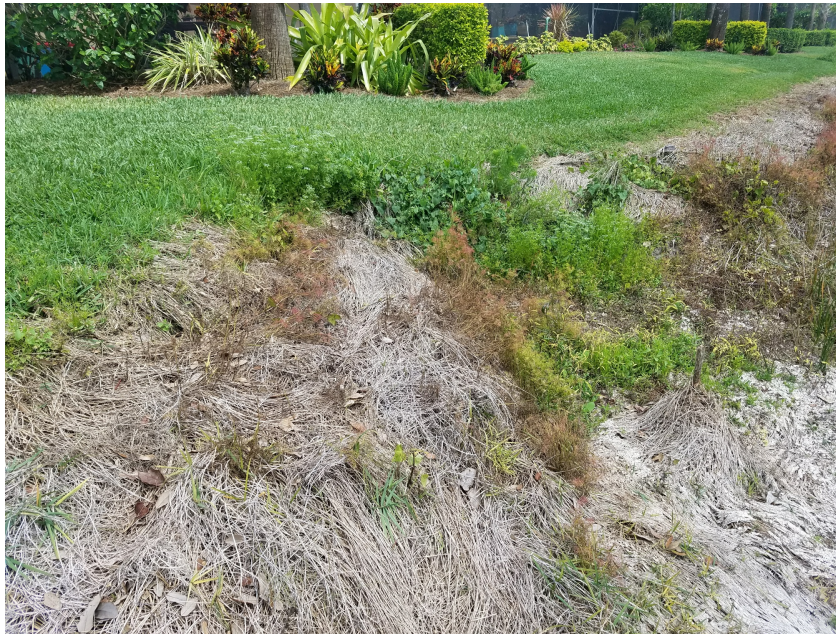
Photo – #18

Sod loss gradually occurring at the top of the lake slope

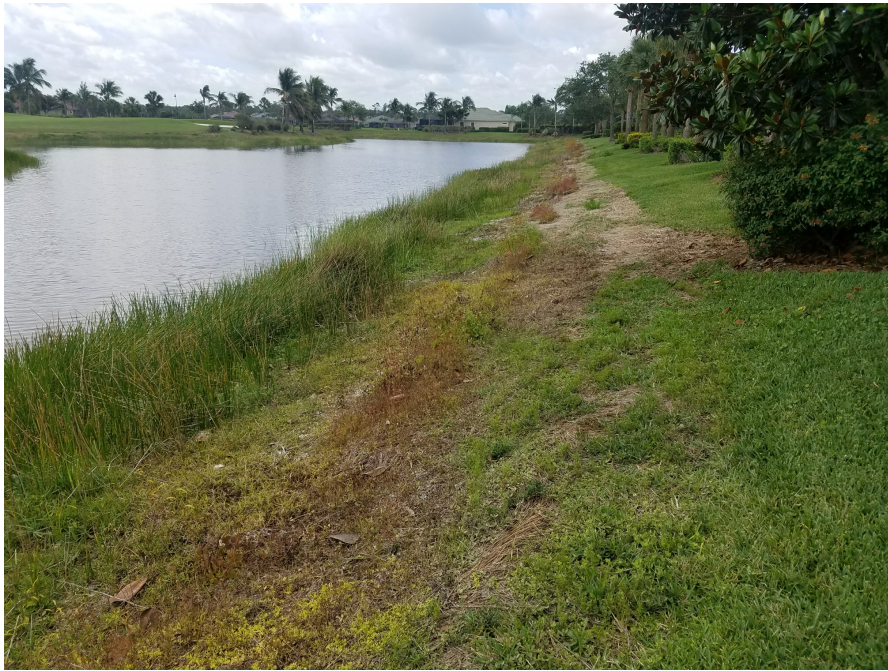
Photo – #19

Major sod loss and erosion is occurring at the top of the lake slope and is gradually progressing to the bottom of the lake slope

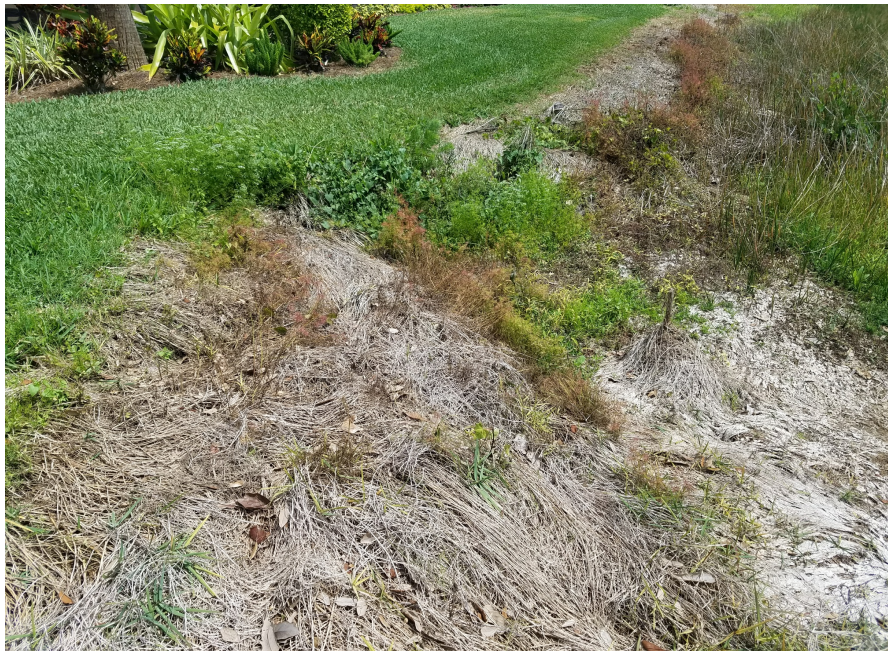
Photo – #20

Major sod loss and erosion is occurring at the top of the lake slope and is gradually progressing to the bottom of the lake slope

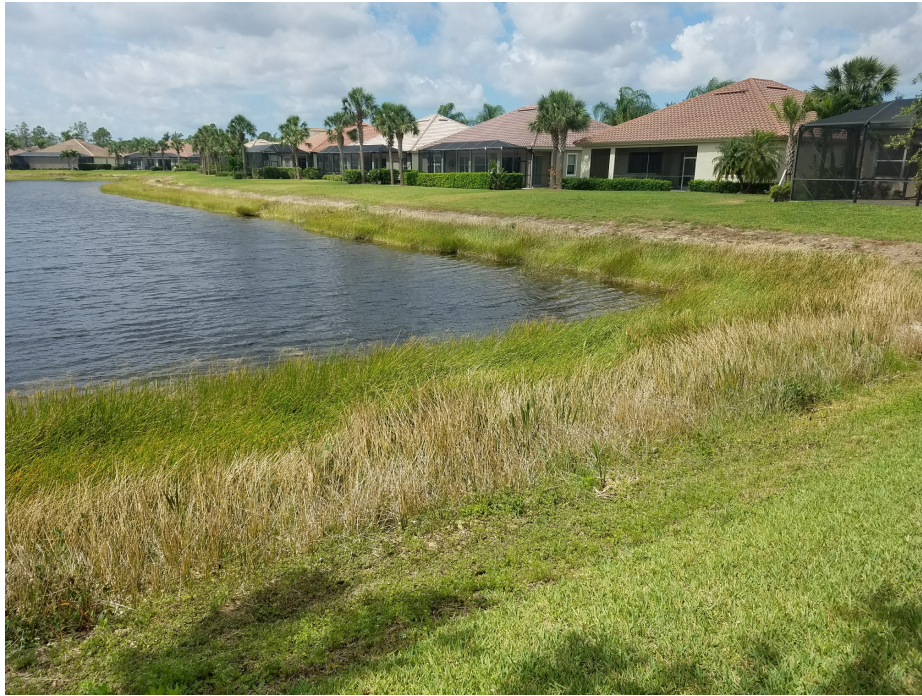
Photo – #21

Minor sod loss and erosion is occurring at the top of the lake slope
